Greener, Leaner and Meaner

How a number of innovations in pavement design and installation saved time, cost and materials on the A45 Weston Favell - Billing trunk road, Northamptonshire.

Authors: Chris Sullivan I.Eng., A.M.I.C.E., M.I.A.T., M.I.H.T. Material Edge Ltd.
Dr.ir. A H de Bondt, Ooms Avenhorn Groep / International bv

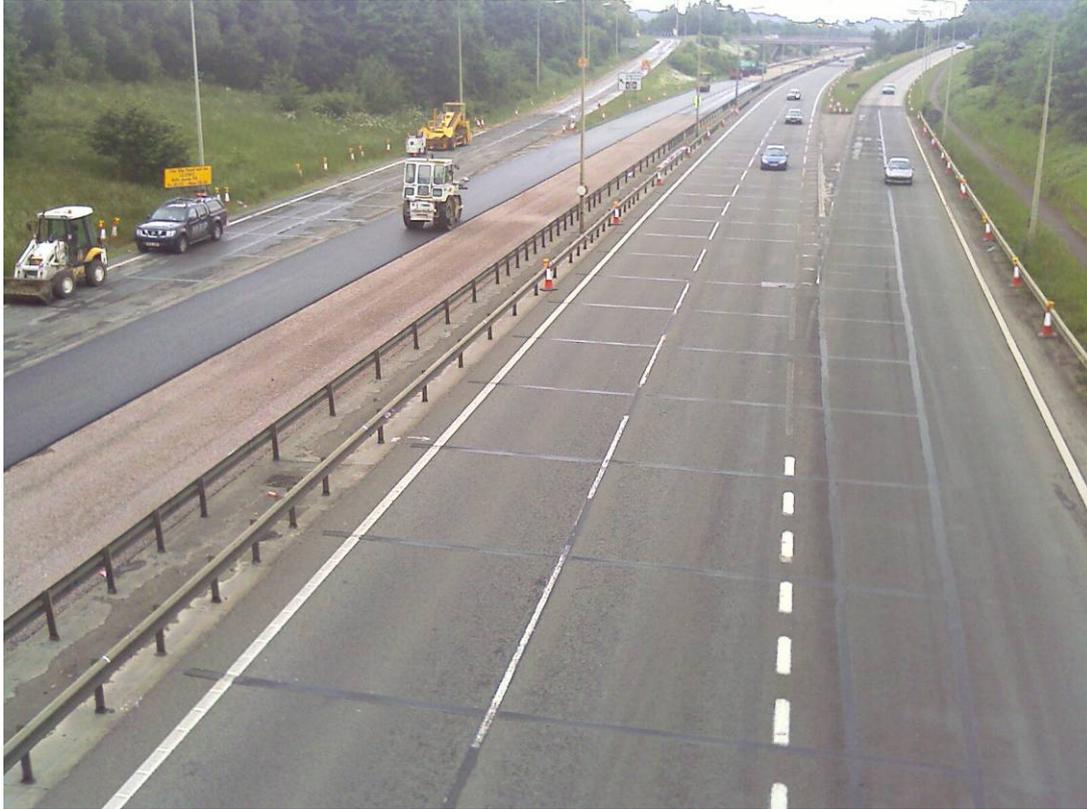
The original reinforced concrete pavement had been overlaid 17 years earlier with a Safepave® thin surfacing layer. This was showing signs of ravelling and stripping particularly around the joints which had been extensively patched and filled. The concrete slabs were showing visible signs of movement and longitudinal cracks were present in some areas.

Picture 2. Highway prior to treatment (right side) and during overlay (left side)

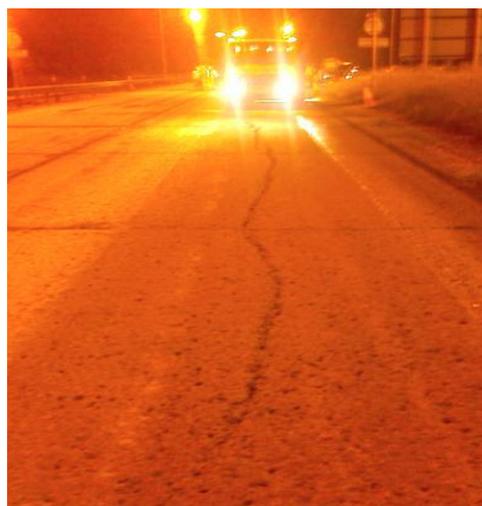
Picture 3. Longitudinal cracks revealed after night time removal of Safepave® and 20mm of concrete surface.

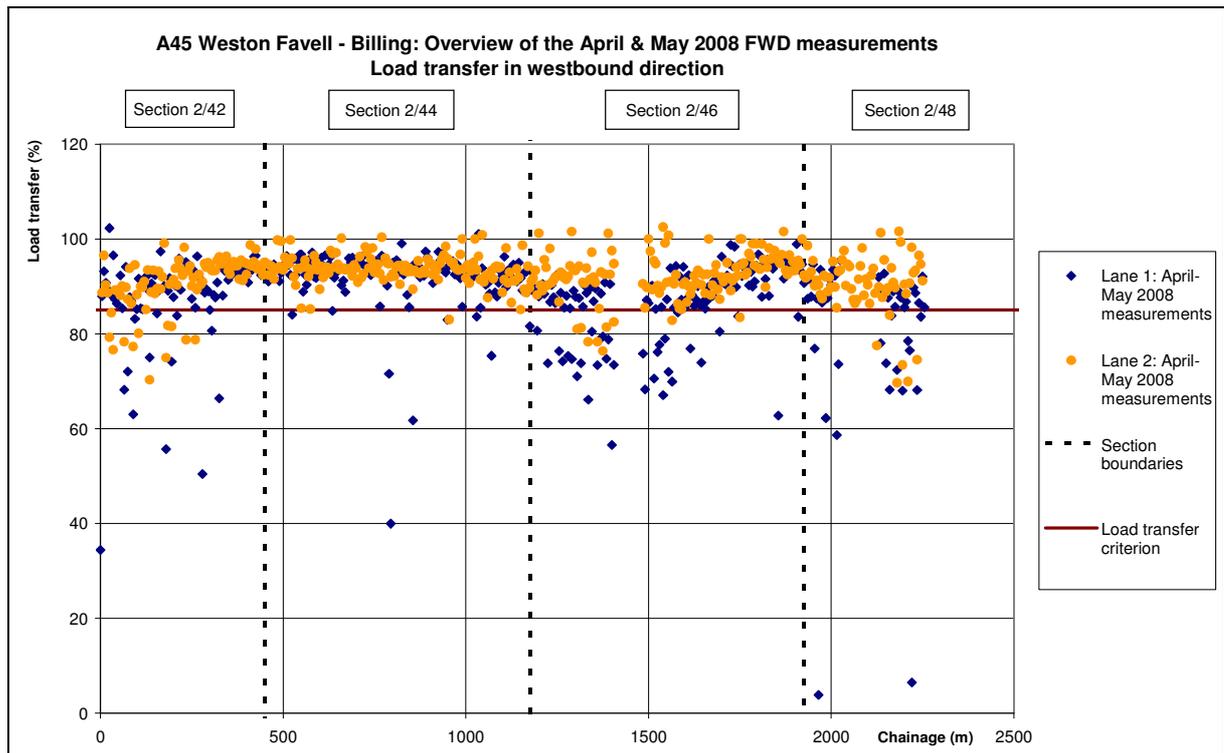
Diagram 1. FWD measurements, load transfer west bound

In order to ascertain the viability of leaving the damaged concrete slabs in place Ooms worked with the TRL to analyse movements and load transfer on the over two hundred 5m bays and longitudinal cracks along the project. These complex finite element analysis calculations had 2 criteria for stage 1 treatment. (See Diagrams 1&3.)

1. At least 85% load transfer at joints was required.
 2. Relative vertical movement between adjacent joints must be less than 50 μ m.
- Where these criteria were not met additional stage 2 measures were deemed to be required in the form of a "Detailed Repair System" designed specifically for this project as described later in this paper.

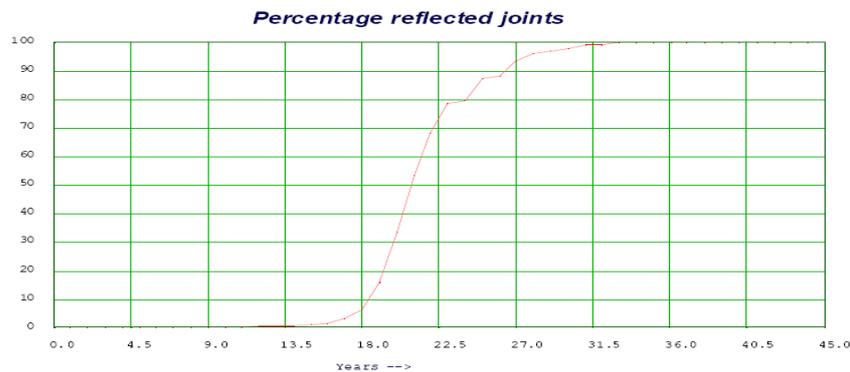
Diagram 2. Expected % reflective cracking performance versus years in service

- Shorten the 8 weekend program to 5 by not removing the damaged concrete bays.
- Provide a design life for a 95% crack free surfacing of more than 10 years, i.e. the expected minimum lifetime of the surfacing.

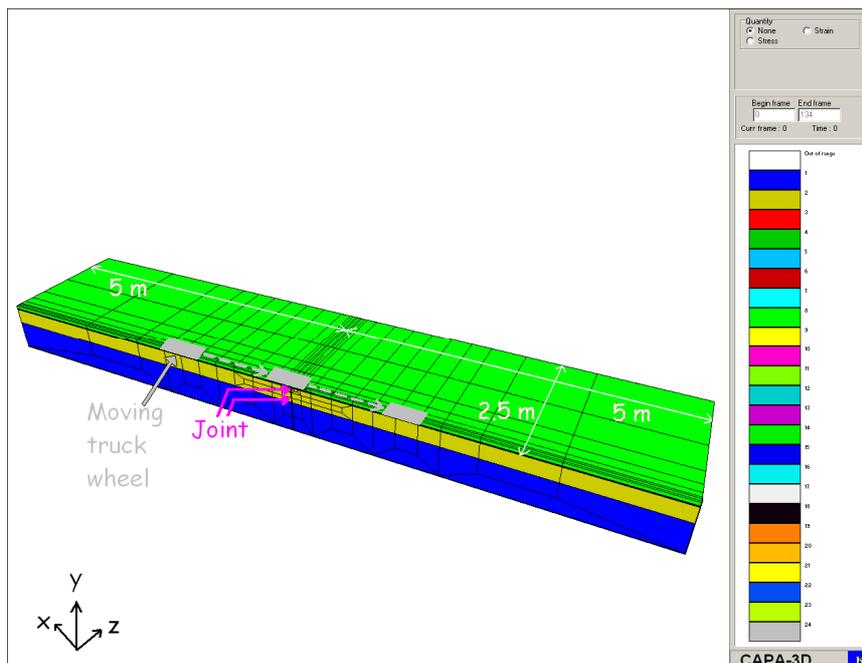
Diagram 3. Finite element analysis mesh used for the A45.**Final design prior to trials.**

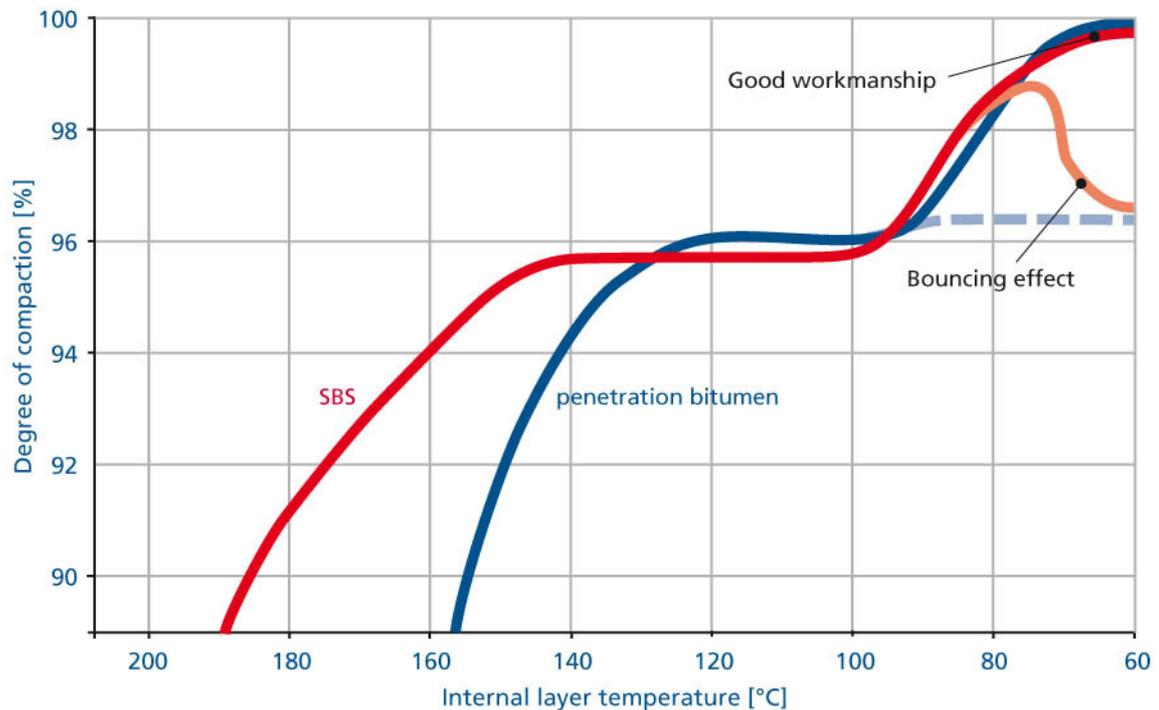
Sketch of compaction mechanism of high-quality SBS modified asphalt

Good workmanship: When continuing compaction till 60 °C (internal layer temperature)

Bouncing effect: When ending compaction at 80-90 °C (internal layer temperature)

Diagram 4. Compaction of high quality SBS PMB's

3. Some fattening up was seen due to over-rolling. This was eliminated by keeping rollers off the mat when it was still very hot (>170°C) and increasing the length of rolling sections to avoid repeatedly traversing certain areas. The roller pattern in Diagram 4 explains this process.

Compaction of Sealoflex® modified SMA requires special attention to eliminate the bounce back effect seen when compacting highly elastic, high quality SBS Polymer Modified Binders (PMB's). Diagram 3 above shows this effect. Rolling was therefore continued until the material reached an internal temperature of 60°C.

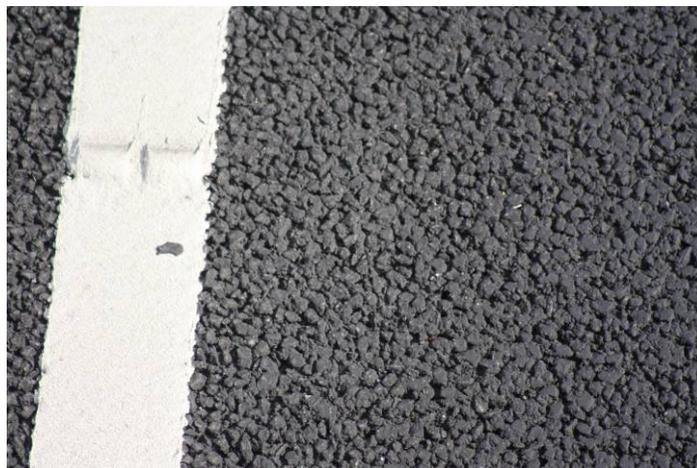
Picture 4. Final texture at >97% compaction.

1. For the modified SMA surface course Ooms require a degree of compaction measurement of >97% of the reference Marshall density achieved in the laboratory. This is further calibrated on site from on going core bulk density results. This differed from the UK method of controlling compaction through monitoring of texture depth and although thought to be difficult to achieve it was in practise much easier than expected and will result in improved durability of the finished surfacing layer.

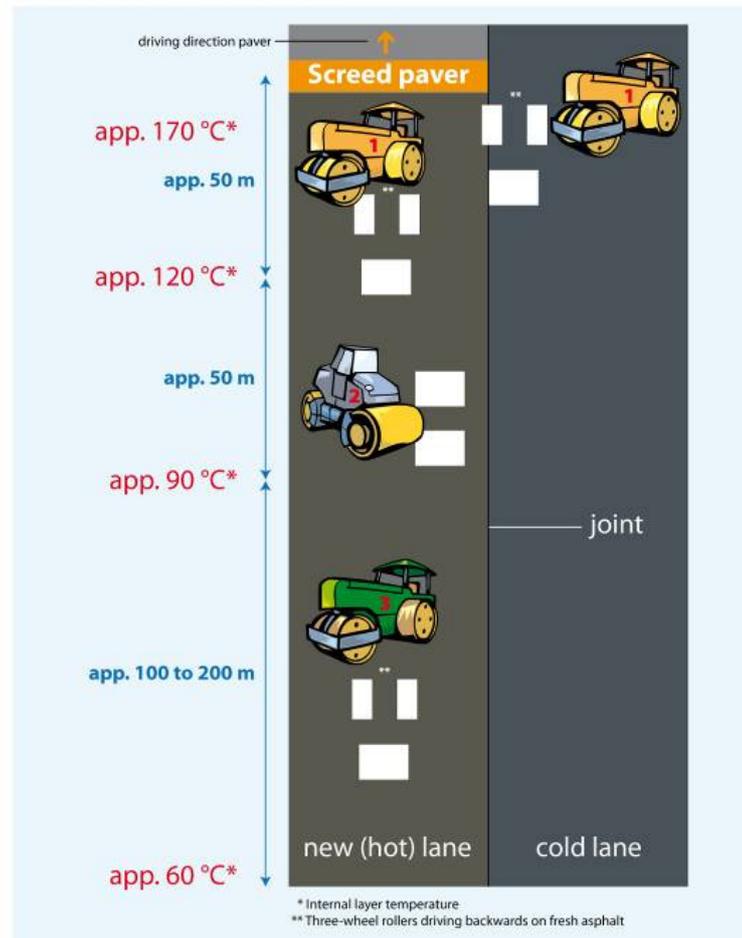
Illustration of Sealoflex® rolling process

project A45 Billing - May/June 2008

Diagram 5. Sealoflex® rolling pattern diagram

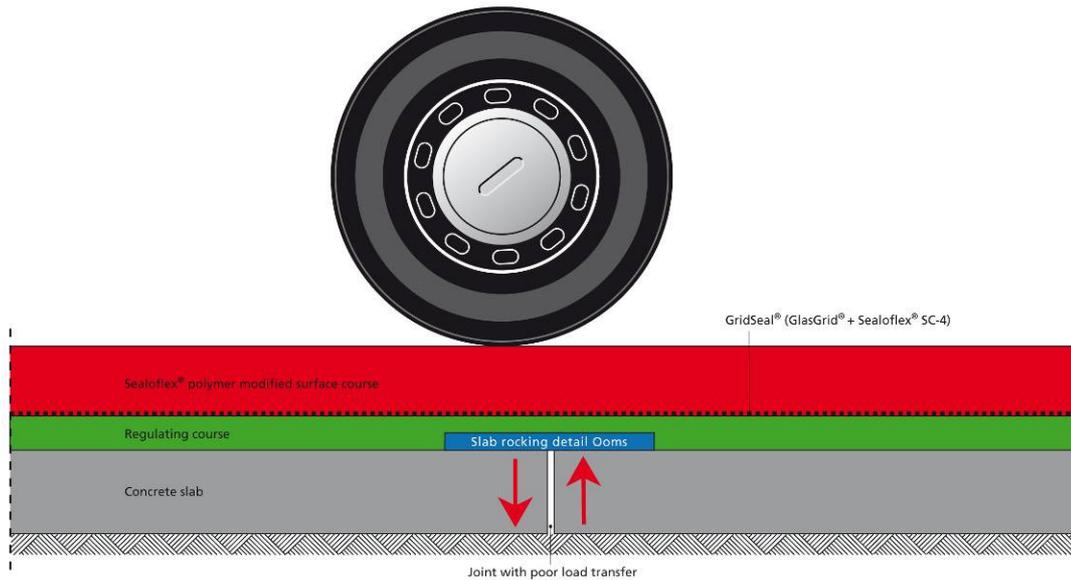
Diagram 6. Detailed Repair System instructions

- The installation of the Detailed Repair System with 20mm of regulating course over it was more difficult to achieve than expected. The conditions needed to ensure success were not always available and dust and moisture on the surface of the milled concrete sometimes resulted in either the tack coat failing under site traffic or the SC-4 and CG200 being pushed by the paver or roller. With careful monitoring it was possible to install this system but recommendations for subsequent installations will include a thicker regulating course. Installation was at the rate of 10 repairs per hour, full carriageway width.

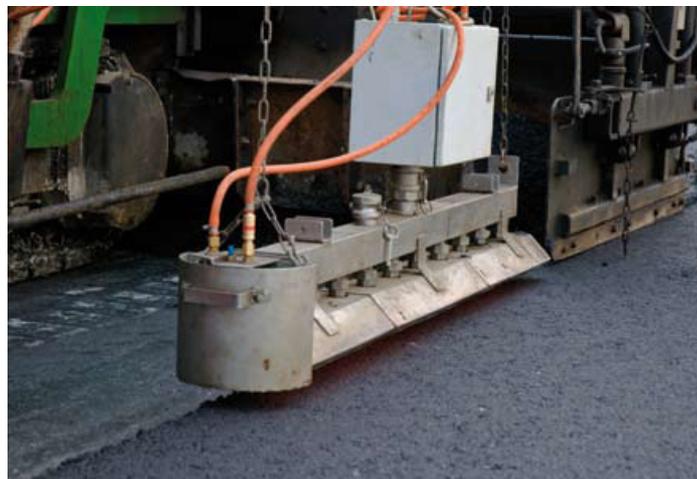
Picture 5. Material Edge, Ecoseam Joint Heater in use.

Due to the inherent elasticity of Sealoflex® modified surfacings after laying and cooling, it is even more critical that longitudinal construction joints in the paved mat are hot jointed, either by paving in echelon or with the use of a joint heater. As a running lane was required for emergency vehicles throughout the contract period, it was not possible to utilise pavers in echelon. Another first therefore was the use of an Ecoseam ceramic joint heater provided by Material Edge which increased the temperature of the cold mat joint to about 110°C prior to paving and rolling in the hot mat alongside. This has provided very tight and almost invisible joints which will be as durable as the rest of the mat and not a future weak spot for ravelling and water penetration as can often be the case. Invisible joint lines also improve safety for traffic driving in poor visibility and at night when joints are sometimes mistaken for traffic demarcation lines.

Joints laid using the Ecoseam joint heater are observed to be very closed and performing well. The SMA in the "control" section appeared after the second summer to have closed up more than the Sealoflex® modified section.

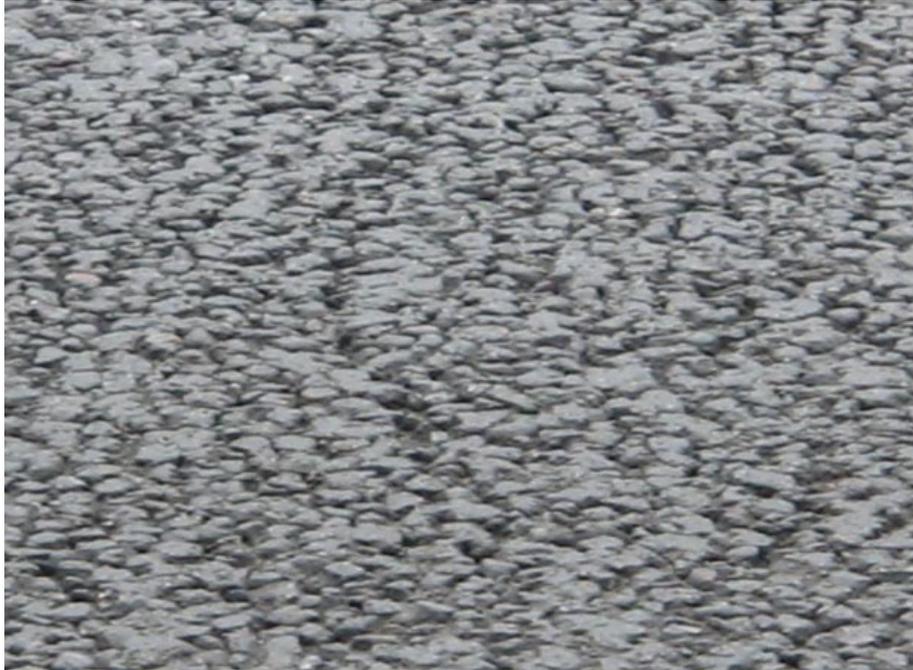
Picture 6. Typical "control test section cracking after first winter

A visual inspection was made at the end of April during which some cracking was observed particularly in the "control" test sections without the GridSeal® and Sealoflex®. These are recorded in table 1 below.

6 cracks in 1600-1700 "control" test section with No GridSeal.

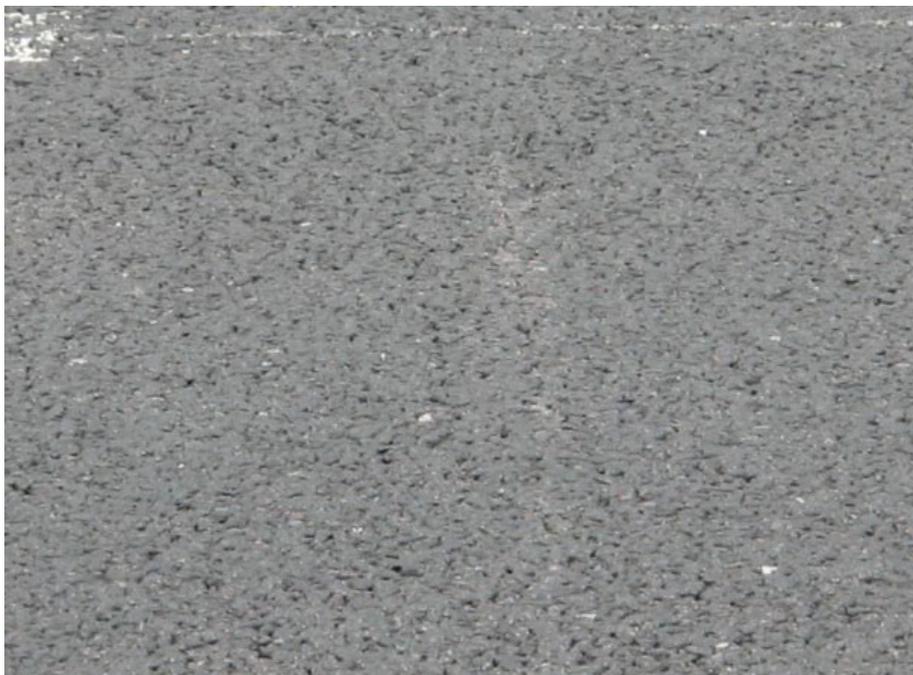
Picture 7 Typical "control" test section cracking with evidence of possible pumping after first winter

3 cracks one with possible pumping in 1900-2000 "control" test section with No GridSeal, thought to be 5m from a detailed repair.
